Manhole Inspection Summary

Manhole # S25K__010MH

Insp Date: **3/26/08 10:21 AM**

Location Address: **1300 S. Carey St**

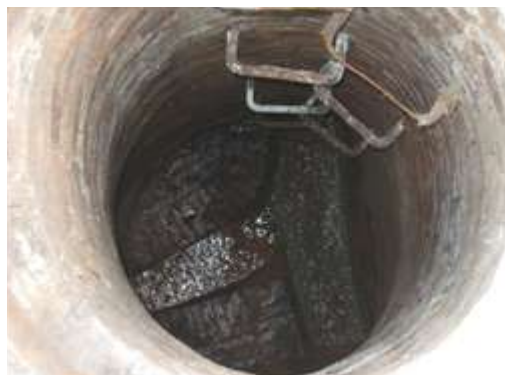
Top View

8 Oclock clogged, no flow

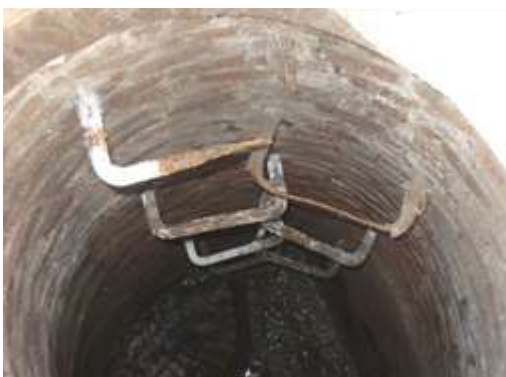
Defect 4

Steps Count: **5** Missing: **1** ☒ **Corroded**

corroded and deteriorating steps with infiltration from top to bottom

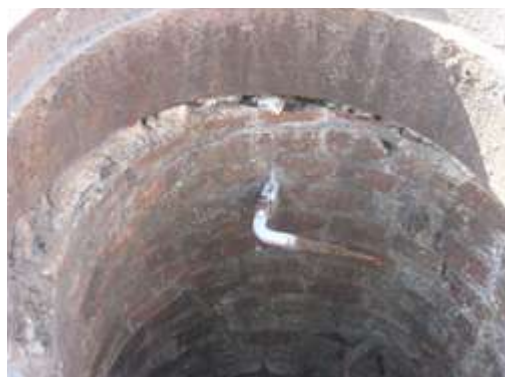
Defect 3

Condition: ☐ Sound ☐ Cracked ☐ Root Intrusion ☒ **Loose Brick** ☒ **Deteriorated**

Infiltration: ☐ None ☐ Joint ☐ Cracks ☒ **Mortar** ☐ Roots ☐ Wall

loose bricks and missing mortar under frame with infiltration

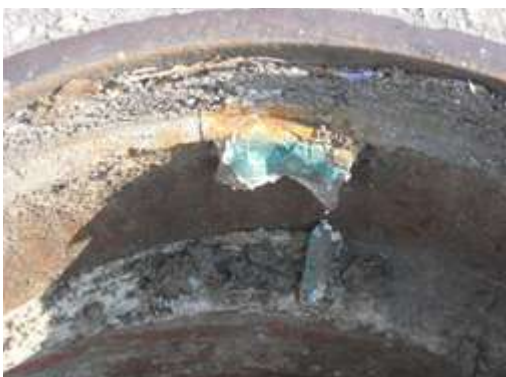
Defect 1

Frame Offset: **2.5** (in.) Condition: ☒ Sound ☐ Cracked ☐ Leaks

frame offset 2.5"

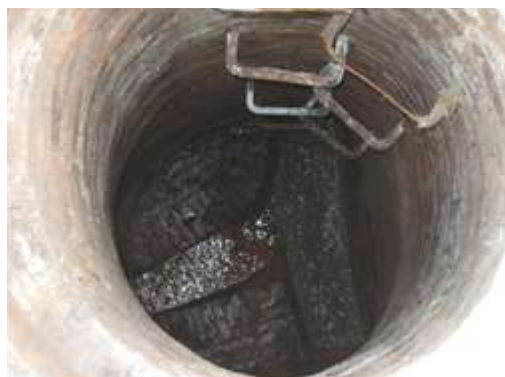
Defect 6

Condition: ☐ Sound ☐ Cracked ☐ Root Intrusion ☐ Deteriorated ☐ Leaks ☒ **Debris**

channel cond debris

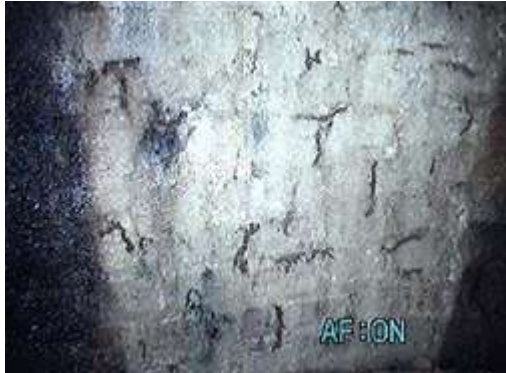
Defect 5

Infiltration: ☐ None ☐ Joint ☐ Cracks ☐ Mortar ☐ Roots ☒ **Wall**

corbel evidence of infiltration

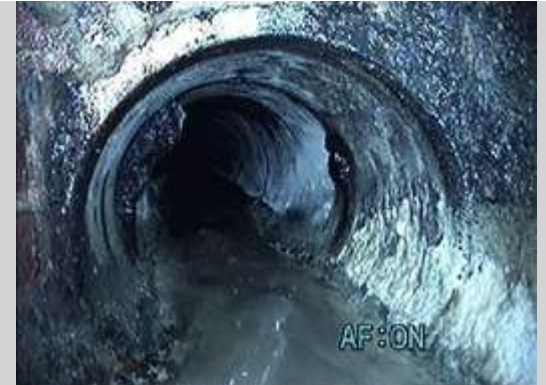
12 O'Clock Outflow

15 in. Circular Gravity Sewer
Pipe Out @ 12 O'Clock

Pipe Height: **15.6** (in.) Rod and Bar (Angled)
Pipe Material: **Clay** ☐ Pipe Lined
Invert Depth: **15.90** (ft.) Flow Characteristics: **Fast**
Deposits: ☒ None ☐ Mud ☐ ~~Gravy~~ ☐ Debris ☐ Grease
Silt Depth: **0** (in.) Deposits Extent:
Infiltration: **None** Pipe Seal Cond: **Sound**

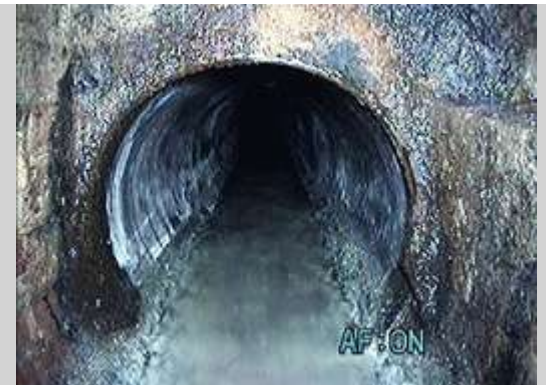
5 O'Clock Inflow

15 in. Circular Gravity Sewer
Pipe In @ 5 O'Clock

Pipe Height: **15.6** (in.) Rod and Bar (Angled)
Pipe Material: **Clay** ☐ Pipe Lined
Invert Depth: **16.00** (ft.) Flow Characteristics: **Fast**
Deposits: ☒ None ☐ Mud ☐ ~~Gravy~~ ☐ Debris ☐ Grease
Silt Depth: **0** (in.) Deposits Extent:
Infiltration: **None** Pipe Seal Cond: **Sound**

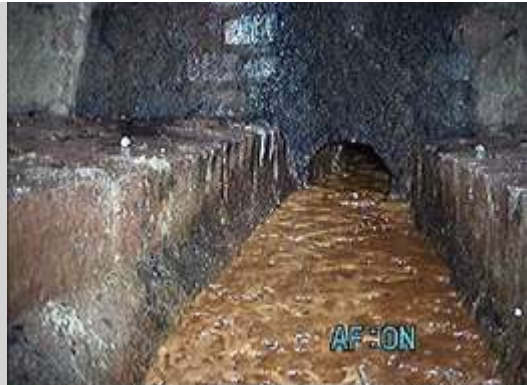
8 O'Clock Inflow

Comments **8 Oclock pipe clogged**

House connection clogged, no flow

Deposits: ☐ None ☐ Mud ☒ **Sludge** ☐ Debris ☐ Grease

Silt Depth: **5** (in.) Deposits Extent: **Heavy**
